Breakage of a Biliary Plastic Stent – A Potential Risk of Sideholes

Biliary stent exchange is usually considered a safe procedure where problems related to manipulation of an occluded stent are seldom experienced. A case of plastic stent breakage, probably related to the stent's design, is reported.

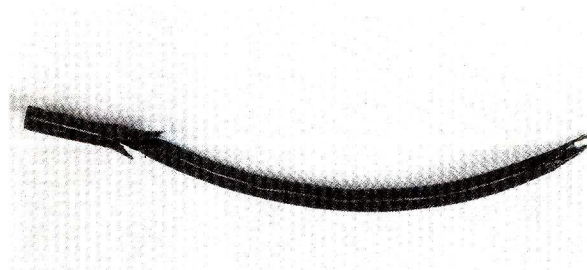
Figure 1: Broken plastic stent; the concave cuts at the point of disintegration are seen. The design of the flaps are seen in the intact distal end.

No similar complication involving plastic stents has been reported, but mechanical breakage of a metal stent has recently been described (1). The design of the present stent, with three closely placed cuts where the short flaps were located, probably caused weakness leading to breakage. Acute angulation during extraction, combined with the flaps being stuck in the tight stricture, is a possible contributing factor. It could be speculated whether the use of a wireguided extraction device (2) would have resulted in uneventful extraction. In this case the "snare beside a wire" technique (3) would probably not have avoided the mishap. The design of the stent in question should be modified to increase the distance between the cuts to strengthen it. Similarly, stents with long flaps, but without sideholes or cuts going completely through the material (4) could be assumed to have weak areas if the cuts are too deep. This should be taken into consideration in the continuing development of single-layer plastic stents.

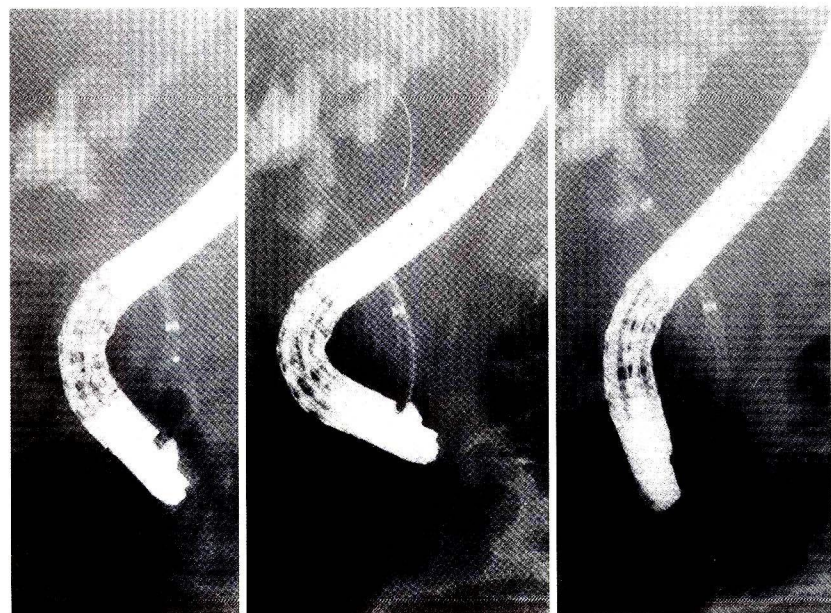
Figure 2: From left to right: the retained proximal fragment stuck in the stricture; passed with a wire; and subsequently passed with a second stent.
