# Percutaneous repair of iatrogenic subclavian artery injury by suture-mediated closure device

Department of Radiology/Interventional Radiology, Tata Memorial Hospital, Mumbai, Maharashtra, India

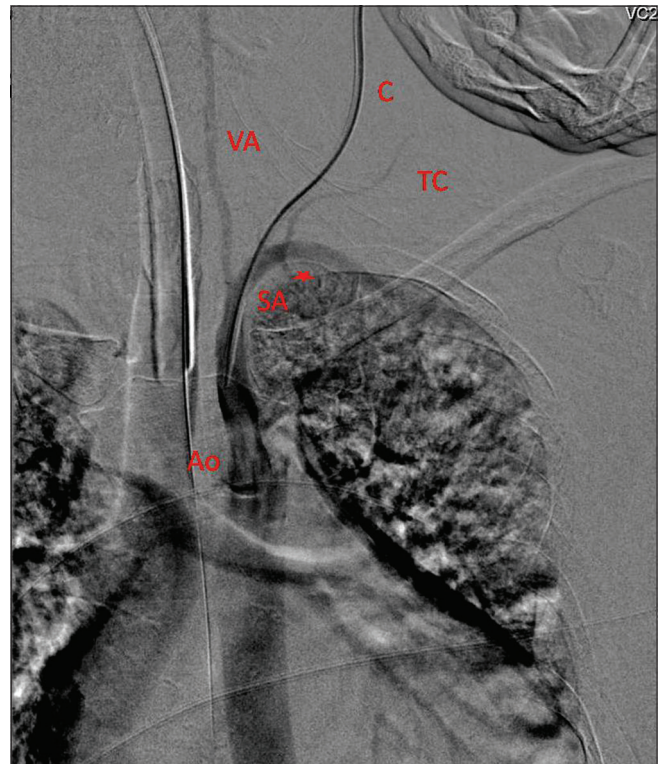
**Figure 2:** Digital subtraction angiography image of contrast injected through catheter confirms its tip in subclavian artery. C - Catheter, SA - Subclavian artery, VA - Vertebral artery, Ao - Aorta, TC - Thyrocervical trunk, \*Left internal mammary artery

In the interventional radiology suite, angiogram was performed through the catheter to confirm its patency and intraluminal location [Figure 2]. Using 4Fr H1 head hunter catheter (Tempo, Cordis Corp, Miami, FL, USA), subclavian angiogram done through transfemoral access revealed a small dissection flap close to the entry site of the catheter [Figure 3]. No thrombus was seen around the catheter and antegrade flow was normal with no filling defect in distal arteries till the palmar arch. There was no active contrast extravasation, pseudoaneurysm, or arteriovenous fistula at the puncture site.
