## Fractured needle during endoscopic ultrasound-guided fine-needle aspiration of a pancreatic head mass

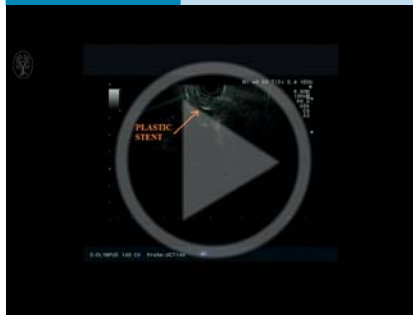
### Video 1

Fractured needle during endoscopic ultrasound-guided fine-needle aspiration of a pancreatic head mass.

After various attempts at retrieval, the needle was grasped from the terminal end using a snare and was removed completely, without any consequences to the patient. The needle segment measured 4 cm (▶ Fig. 3, ▶ Video 1). There was no obvious cause of this incident. However, it is possible that the plastic stent could have been a relevant factor in the breaking of the needle.
