# Unusually High Rate of Early Failure of Tibial Component in ATTUNE Total Knee Arthroplasty System at Implant–Cement Interface

J Knee Surg 2017;30:435–439.

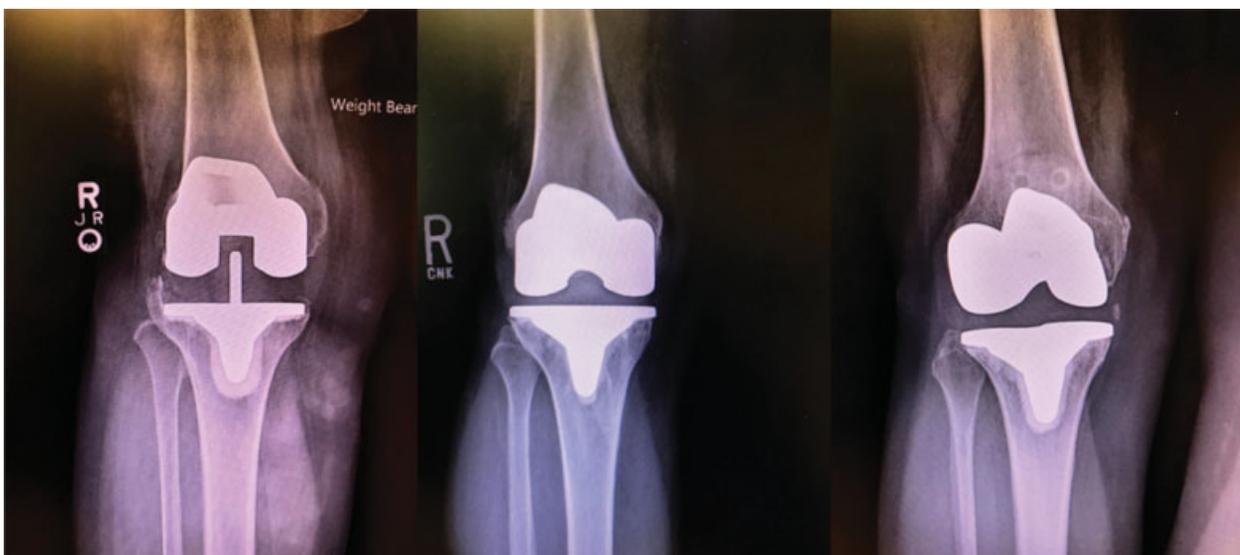
Radiographic evaluation of the 15 knees that received this implant demonstrated only 2 (13%) to have evidence of radiolucencies. In the first case, on the AP radiograph, there was evidence of radiolucency in zones 1 and 2. On the lateral radiograph, there was evidence of radiolucency in zone 3A. For the second case, there was evidence of radiolucencies in zones 1, 2, and 3L on AP radiograph, and zones 1, 2, and 3A on lateral view (→ Fig. 1).

**Fig. 1** Anteroposterior radiographs prior to revision surgery.

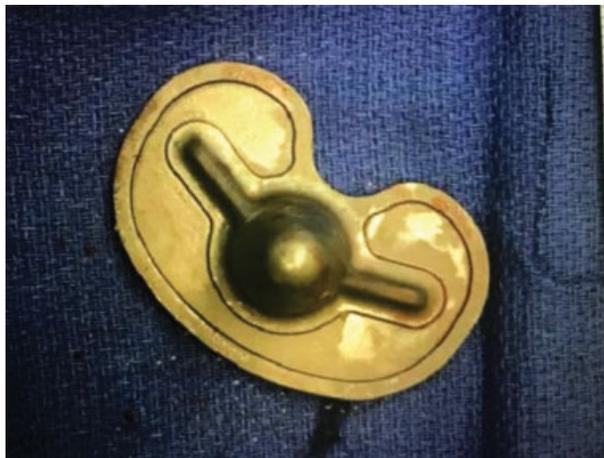
In all revision cases described in this study, there was an apparent loosening of the tibial component with gross implant motion between the tibial tray and tibial bone cement. In one patient, the tibial tray would piston 4 mm as the knee was brought from flexion to extension, and would lift off from the tibial bone cement when the leg was manually distracted intraoperatively. All patients underwent revision of both tibial and femoral components. In all tibial cases, the tibial component had debonded and was easily separated from the cement mantle. Upon removal of the tibial baseplate, the inferior surface of the tibial baseplate was clear of cement (→ Fig. 2), while all the cement was strongly adherent to the tibial bone (→ Fig. 3). The femoral components were securely attached to the femoral bone with no apparent loosening. Upon explantation of the femoral components, the cement was strongly adherent to the implant surface in all cases (→ Fig. 4).

**Fig. 2** Inferior surface of the tibial component immediately after explantation.

cement–bone interfaces, which may contribute to the loosening. The design of the inferior surface of the tibial component appears to have rounded edges and less insets for cement interdigitation relative to the prior designs. In addition, the tibial keel appears to have less rotational phalanges which may lead to less rotational stability and less macro-interdigitation. Furthermore, according to the manufacturing literature, the backside surface of the tibial component has markedly different surface roughness when compared with the femoral component (60 vs. 220 grit blasts). All of these factors may contribute to the propensity of this implant for early loosening through higher loads and less stability at the tibial implant–cement interface.

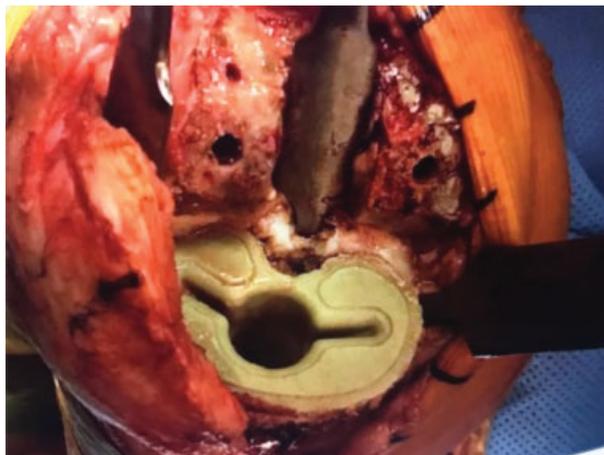
**Fig. 3** Cement adherent to the tibial bone after explantation of tibial component.

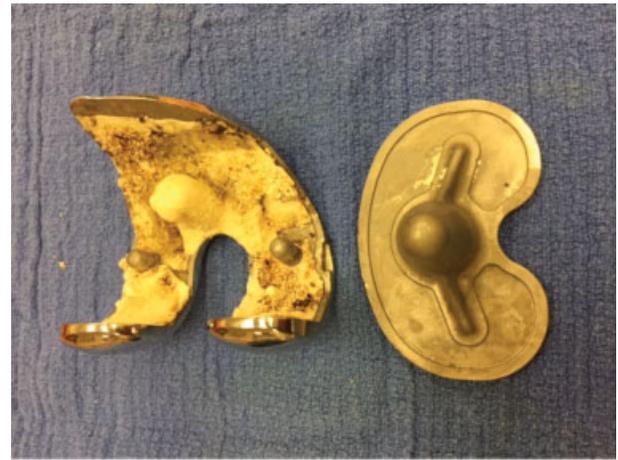
**Fig. 4** Cement adherent to femoral component but not tibial component.
