Effect of Different Ceramic Materials on Fatigue Resistance and Stress Distribution in Upper Canines with Palatal Veneers

Eur J Dent 2022;16:856–866.

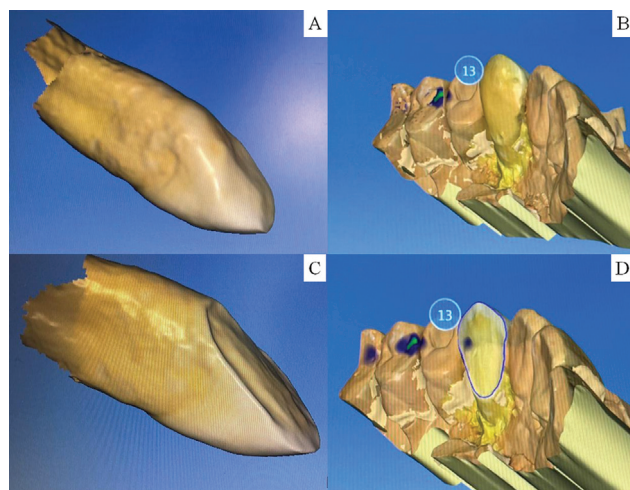
Fig. 1 Virtual impression (computer-aided design) from a representative sample before (A and B) and after preparation (C and D) and delimitation of the restoration margin.

At first, all teeth were scanned with an intraoral scanner (CS3600, Carestream, Atlanta, Georgia, United States) (→ Fig. 1) to obtain each anatomy prior to the preparation. Then, 45 standardized anatomical preparations were made by a single operator, in extracted healthy human canines with 1.2 mm-thick uniform wear, using counter multiplier angle 1: 4.5 with refrigeration (Alegra Led G, Wilcos, Petrópolis, Rio de Janeiro, Brazil) and diamond burs with spherical and candle flame shape (KG Sorensen, Cotia, São Paulo, Brazil). To standardize the preparation, total shape of a 1.2 diameter diamond bur was used and only one experienced operator performed all the preparations. This preparation measurements were chosen because it is a value in the range of the three materials' indication. According to the literature, the average enamel thickness in canine tooth is of 827 ± 196

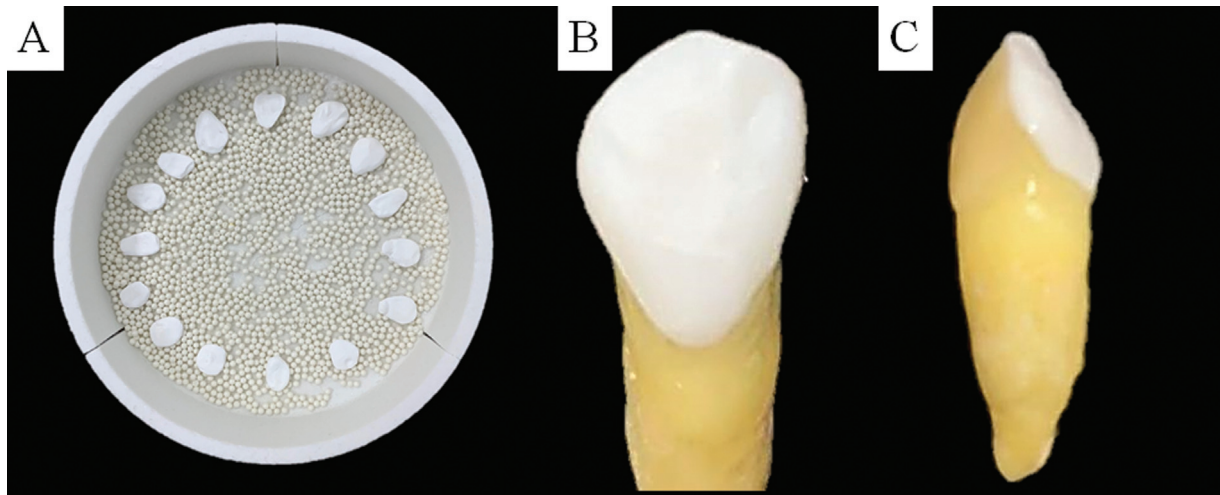
Fig. 2 Yttrium oxide-stabilized tetragonal zirconia samples prior to the sintering process (A), and after cementation in palatal view (B) and lateral view (C).

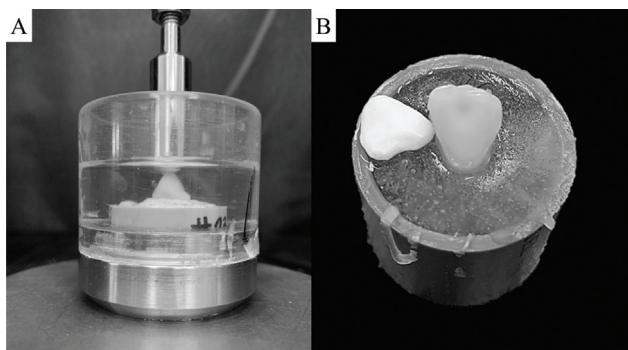
Fig. 3 Universal testing machine during the compressive test (A). Yttrium oxide-stabilized tetragonal zirconia representative sample right after monotonic test with adhesive failure (B).

Initially, three restorations from each group were submitted to the load-to-fracture test, under compressive load with samples immersed in distilled water (► Fig. 3). For this, the specimens were positioned in a universal testing machine (EMIC DL 1000; EMIC, São José dos Pinhais, São Paulo, Brazil). Then, an increasing load using a 1000 kgf load cell and a speed of 1.0 mm/min was applied. The load application was performed with a 4.6 mm diameter steatite piston in the palatal surface of the restorations. The choice of this material as antagonist was due to its elastic modulus close to human dental enamel.²⁰ The mean of the maximum load values, in N, for each experimental group was used as the basis for

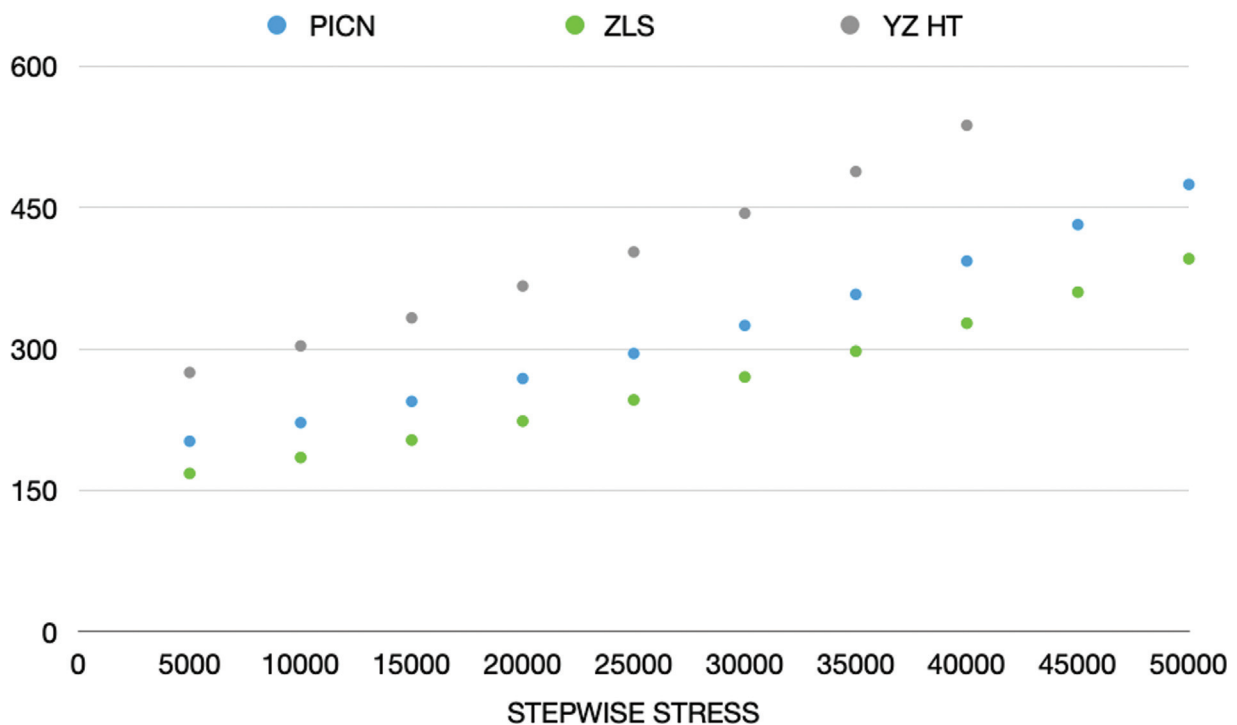
Fig. 4 Graph with fatigue profiles referring to the accelerated life test of the polymer-infiltrated ceramic network (PICN), zirconia-reinforced lithium silicate (ZLS), and Yttrium oxide-stabilized tetragonal zirconia (YZHT) groups.

Brazil). The progressive steps were defined based on the results of the monotonic test for each material.

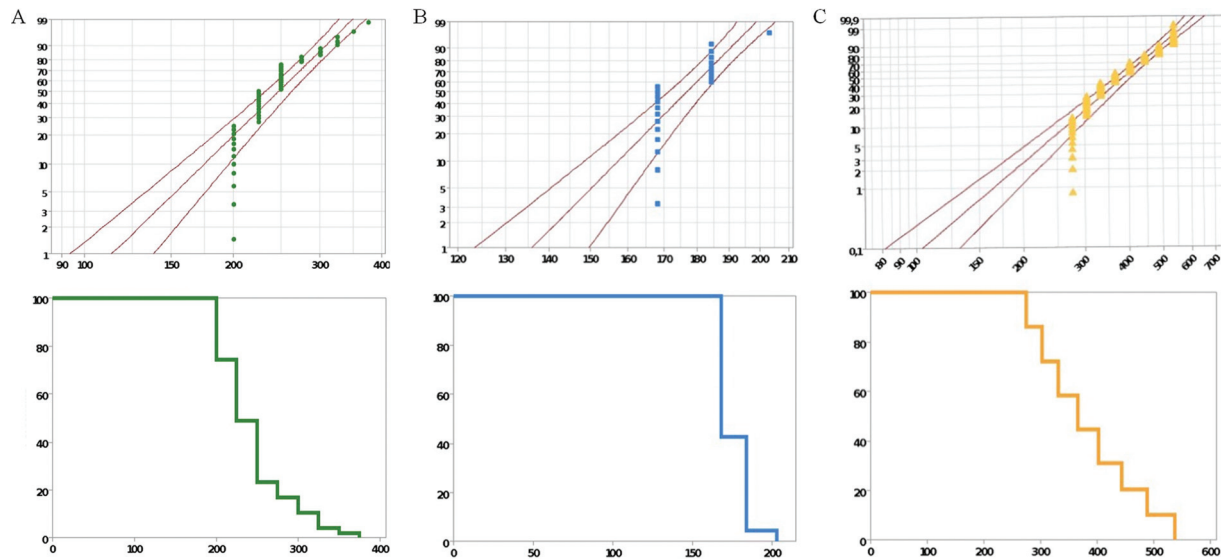
Fig. 5 Survival probability graph with Weibull and Survival load using Kaplan–Meier method; for polymer-infiltrated ceramic network (A), zirconia-reinforced lithium silicate (B), and yttrium oxide-stabilized tetragonal zirconia (C).

The number of cycles to failure was used for survival analysis by Kaplan–Meier tests without direct comparison between materials because of the use of different fatigue profiles. The probability of failure was calculated for different step intervals (Minitab, v16.1.0; Minitab, LLC). The two-parameter Weibull failure probability analysis (► **Table 3**) provided the β value (β), which is a shape parameter and describes the behavior of the failure rate over time. The parameter η (η) represents the characteristic life of the samples, in which 63.2% of failures occur (► **Fig. 5**).

The Kaplan–Meier method (log-rank $p < 0.001$) was applied with a confidence level of 95%. **Table 3** shows, through the Weibull modulus, the values of the shape and scale parameters for each material group. In the PICN group, shape was 5.43 and scale was 264, ZLS had a shape of 36.14 and a scale of 380.67, and YZHT had a shape of 4.95 and 417.38. Higher values for shape represent failure rate that increases with time, which would be indicative of future problems regarding wear/failure or even end of material life. However, higher values for scale represent the survival reliability defining the data distribution during the loading.

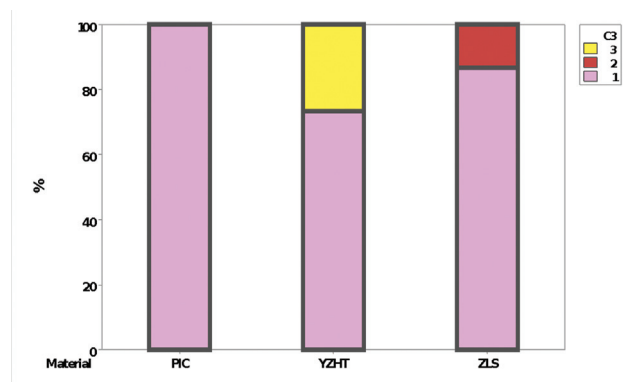
Fig. 6 Failure mode represented by numbers: 1—crack or partial fracture of the restoration, 2—catastrophic fracture of the restoration in multiple fragments, and 3—detachment of the veneer. PICN, polymer-infiltrated ceramic network; ZLS, zirconia-reinforced lithium silicate; YZHT, yttrium oxide-stabilized tetragonal zirconia.

All three groups had a crack or partial fracture of the restoration; only the ZLS group presented catastrophic failure in multiple fragments; and the YZHT group, in addition to the crack or partial fracture of the restoration, presented facet debonding. (**Fig. 6**)

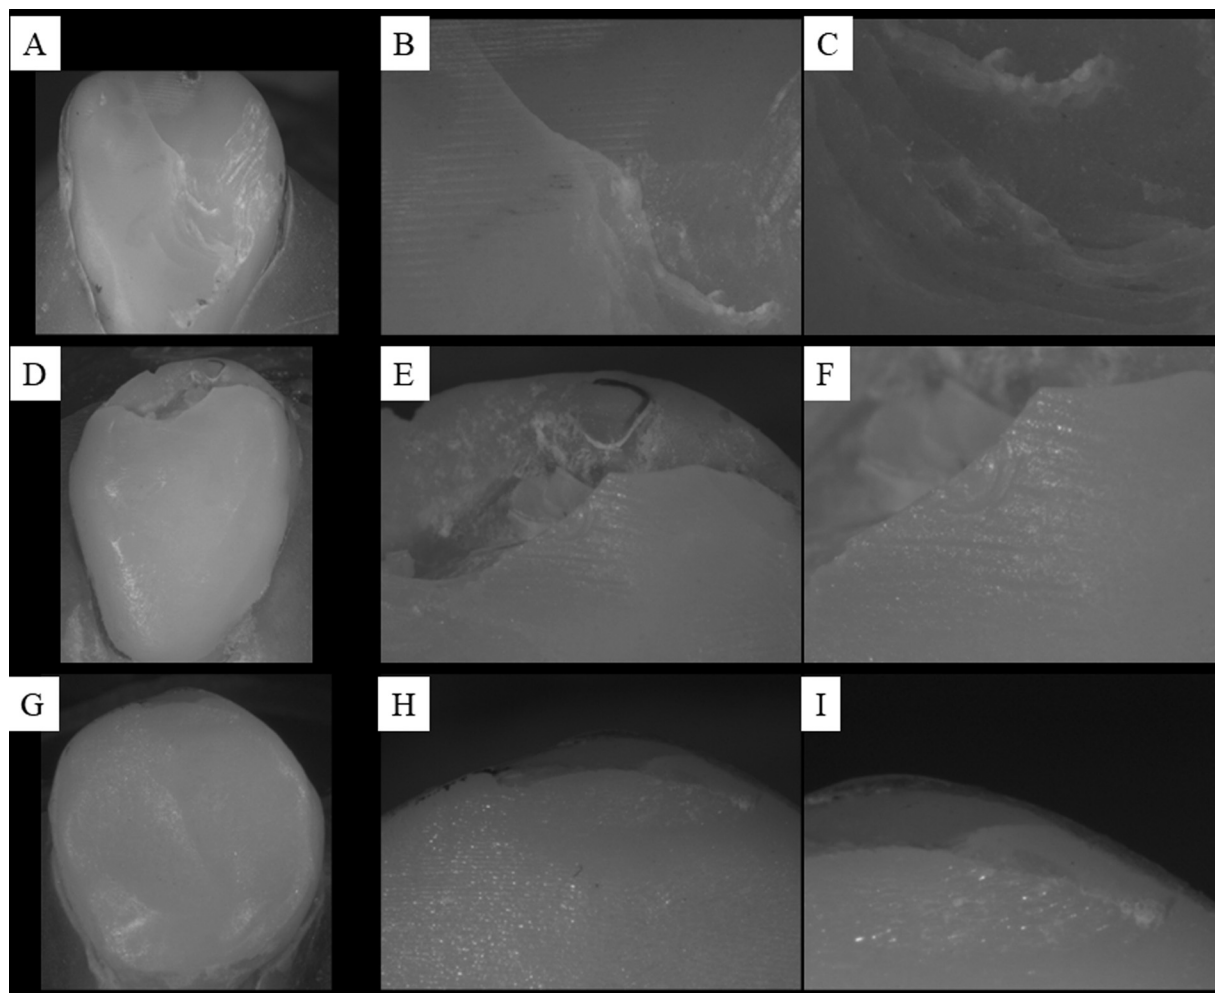
Fig. 7 Sample after fatigue test. It is possible to observe cracks in the restoration in the analysis under a stereomicroscope with respective magnifications of 10x/25x/45x. In sequence polymer-infiltrated ceramic network (A–C), ZLS (D–F), and yttrium oxide-stabilized tetragonal zirconia (G–I).

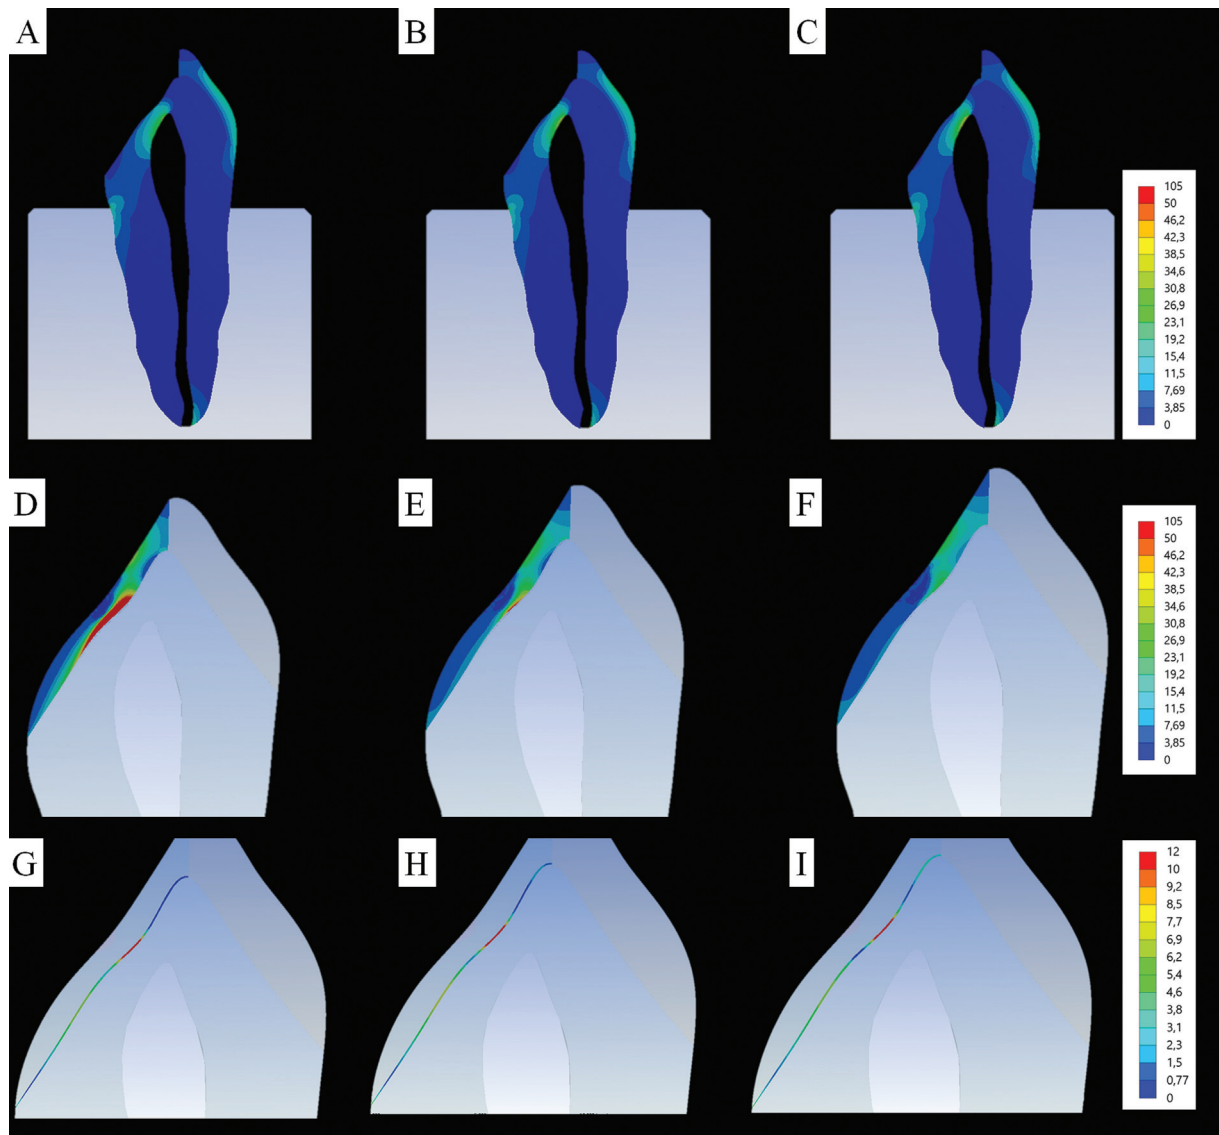
Fig. 8 Maximum principal stress (MPa) in dental substrate, at the veneer and the cement layer for yttrium oxide-stabilized tetragonal zirconia veneer (A), zirconia-reinforced lithium silicate veneer (B), and polymer-infiltrated ceramic network veneer (C).

Assuming the maximum principal stress criterion, which demonstrates the resulting tensile stress on the structures involved, it is possible to separately observe tooth, restoration, and resin cement in **Fig. 7 (A–I)** respectively. In **Fig. 7 (D–F)**, it is possible to observe a similar trend between the models, with no visible difference for the qualitative results of stress.

However, for the result of stress in the palatal restoration, there is a visible difference in the magnitude of maximum stress magnitude in the intaglio surface of the veneer. Basically, the tensile stress accumulated in the adhesive interface region is proportional to the elastic modulus of the restorative material.

As for the resin cement layer, small differences are noticed in relation to the highest values in the red fringe of the numerical scale. However, in the apical region of the preparation, a small but visible difference can be observed be-
