Interventional Closure of a Ruptured Sinus of Valsalva with a Konar-Multifunctional Device

Aorta (Stamford) 2022;10:259–262.

A 14-year-old girl with trisomy 13 presented with signs of respiratory failure. This was caused by the rupture of a sinus of Valsalva aneurysm into the right atrium. A Konar Multifunctional Occluder was used for closure. This is indeed the first report of treatment of this disease with this device.

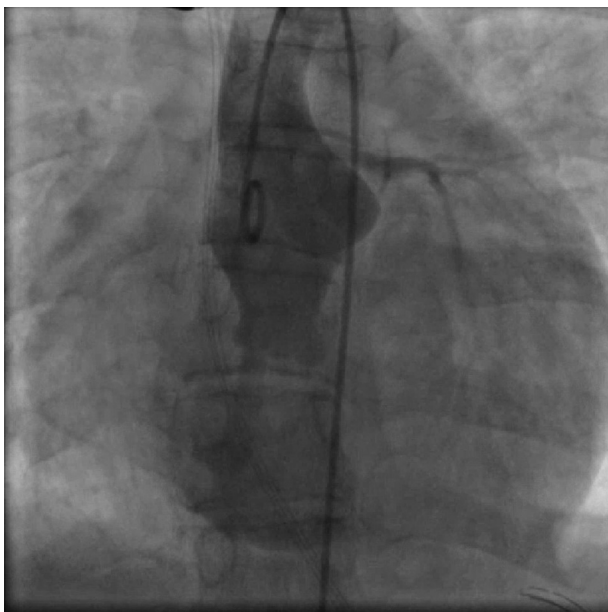
Fig. 2 Angiography in the ascending aorta shows the abnormally shaped sinus of Valsalva with a connection to the right atrium.

Aortography showed a very unusual shape of the enlarged sinus of Valsalva (▶ Fig. 2) with a connection to the right atrium of approximately 5 mm.

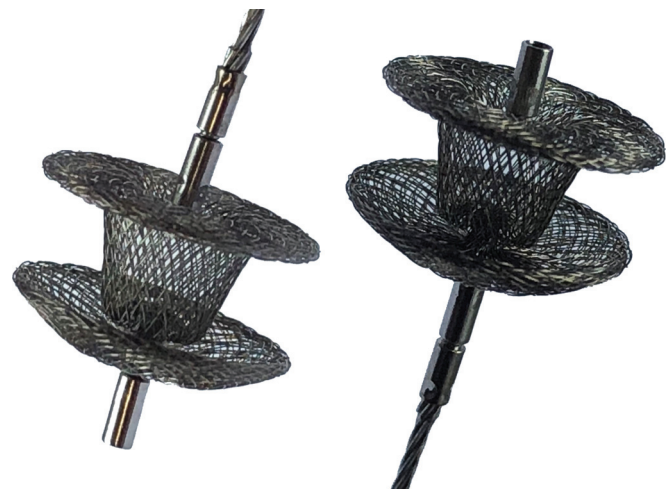
Fig. 5 Konar Multifunctional device size 8/6. The device can be attached to the delivery cable from both sides.

The Konar MFO (Lifetech, Shenzhen, China) is a double disk device resembling a short (4 mm) duct occluder, with the second disk attached to the body by a small cone-shaped connection. It can be screwed onto the delivery cable from both sides, hence allowing deployment in both directions (► Fig. 5). It comes in various sizes. Smaller sizes without any polytetrafluoroethylene polymer membrane can be delivered through a small delivery sheath or catheter, comparable, that is, to Amplatzer vascular plugs, which have also been used to close such defects.⁵ In these, the disks and body of the device have the same diameter. Here, a bigger device would have been necessary. Angulation within the aneurysm could have compromised effectiveness.
