Broken and Retained Tip of Liposuction Cannula in the Scalp

Indian J Plast Surg 2024;57:243–244.

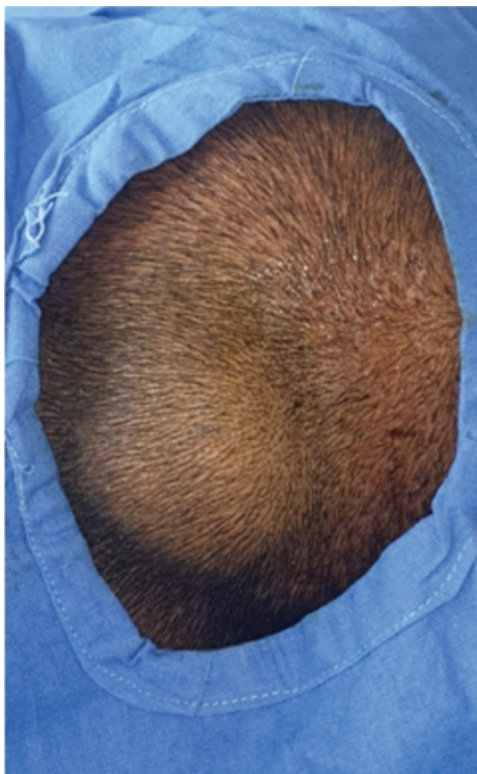
Fig. 1 Lipoma over the occipital region.

A 30-year-old male presented with lipoma over the occipital region (►**Fig. 1**). The patient was taken up for liposuction under tumescent anesthesia after confirmation by fine-needle aspiration cytology. The procedure was

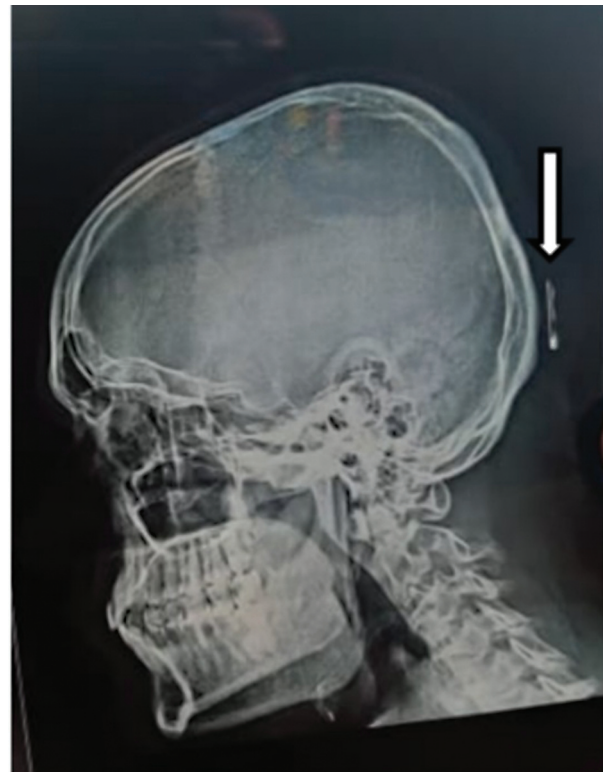
Fig. 2 Radiograph showing the retained broken cannula tip (white arrow).

carried out with a 2.5-mm cannula. During the procedure we realized that the tip of the cannula was broken while reinsertion. After confirming that the tip is not in the drapes and has not fallen on the floor, the patient was immediately sent for a radiograph of the head and neck to confirm the site of the retained broken cannula tip, as there was no portable X-ray in day care center.

The radiograph showed the broken tip retained at the site of liposuction (►Fig. 2). The site was immediately explored under local anesthesia by extending the incision done for liposuction and the broken tip was retrieved (►Fig. 3).

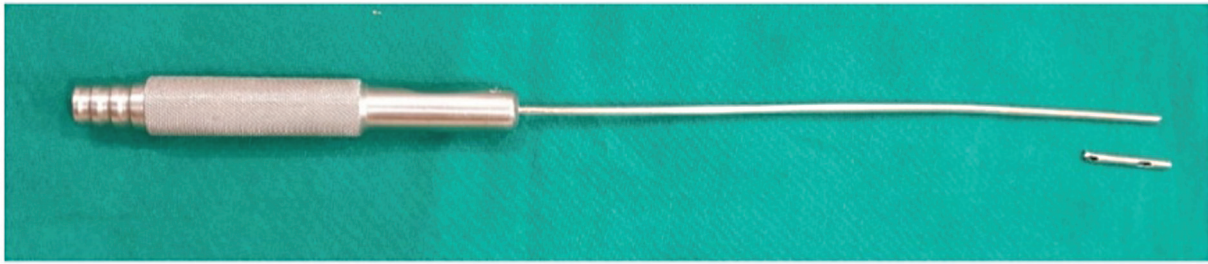
Fig. 3 Showing broken cannula tip on the right with the cannula on the left.

The breakage of the liposuction tip could be due to various reasons. Old cannula, which is used for years, might have lost its tensile strength, bend at the junction of the holes in the cannula, rusting inside the cannula which is not noticed by the surgeon or the operation theatre staff, faulty technique, redo liposuction in fibrous area, and repeated autoclaving of the cannula can also reduce the tensile strength. In our case, the cannula was old and we could have hit either the bone or superior nuchal line of the occipital bone repeatedly, minimal and tight space, galea aponeurotica, and the round contour of occipital area, cannula movement could have been hindered thereby contributing to the breakage of the tip in our opinion.

Regular change of cannulas and inspecting for any bends or cracks in the cannula could avoid this complication. Being in the scalp, it was relatively easy to remove the cannula with marginal extension of the primary incision.
