Changes in the surface of bone and acid-etched and sandblasted implants following implantation and removal

How to cite this article: Eroglu CN, Ertugrul AS, Eskitascioglu M, Eskitascioglu G. Changes in the surface of bone and acid-etched and sandblasted implants following implantation and removal. *Eur J Dent* 2016;10:77-81.

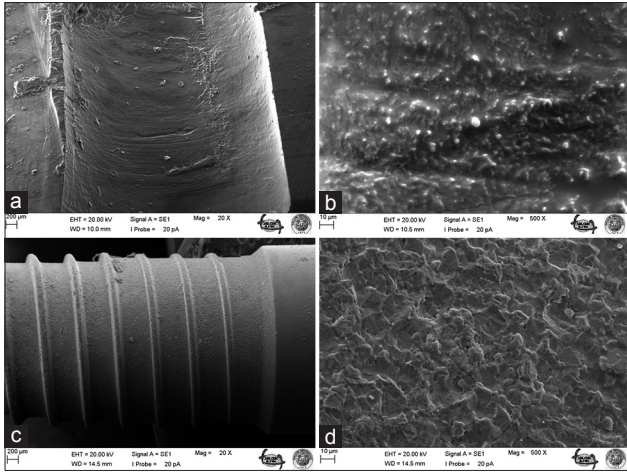
Figure 1: Bone surface before A implant screwing under $\times 20$ (a) and $\times 500$ (b) magnifications; surface of unscrewed A implant under $\times 20$ (c) and $\times 500$ (d) magnifications

The most striking outcomes of the clinical assessment of implant and bone surfaces during scanning electron microscopy examination were obtained at $\times 20$ and $\times 500$ magnification [Figures 1-6], which revealed that the screw configuration in the bone and all three implant types are damaged by implant removal. At $\times 20$ and $\times 500$ magnification, comparison of the surfaces of the implants that were removed with those that were not used shows compression-type deformation in implant A [Figure 2d], patchy micro-holes on the surface of implant B [Figure 4d], and the removal of bony tissue along with the screw configuration in implant C [Figure 6c]. We can see these type of deformations on the bone surfaces which contacted with the implants A and C surfaces [Figures 2b and 6a]. At $\times 20$ magnification, it was determined that vertical sulci present in the surface design of all the implants used caused an accumulation of bone particles [Figures 2c, 4c, and 6c]; nevertheless, no compression was observed. In the case of implant A, it was found that the surface of the unused control was not homogenous [Figure 1c] and its removal produced microfractures in the bone surface [Figure 2a]. When the screwed and removed implant surfaces structure examined under $\times 500$ magnification, on A implant's surface sharp scratches, on B implant's surface rounded mesh type and on C implant's surface round particulate type deformation were investigated [Figures 2d, 4d, and 6d].

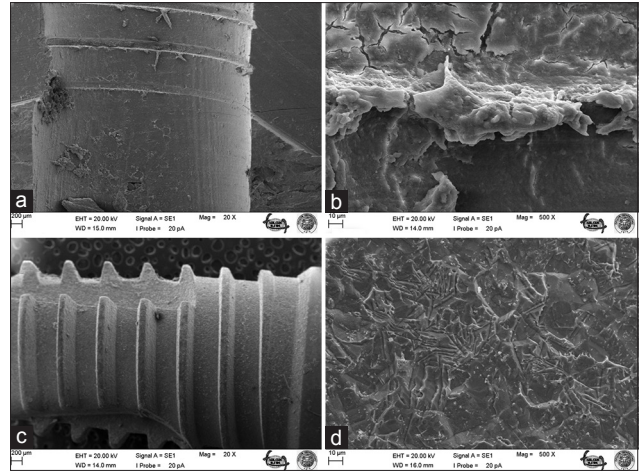
Figure 2: Bone surface after removal of A implant under $\times 20$ (a) and $\times 500$ (b) magnifications; surface of A implant after screwing and removal under $\times 20$ (c) and $\times 500$ (d) magnifications

Given the limitations of this study, it cannot be known for certain at what stage in the implantation and removal procedure the micro-fractures in implant A were produced; however, it is considered that they most likely occurred during the screwing process. Of the implant types tested, only implant A was found to have an inhomogeneous surface. This is significant, as ensuring homogeneity in the surface of implants

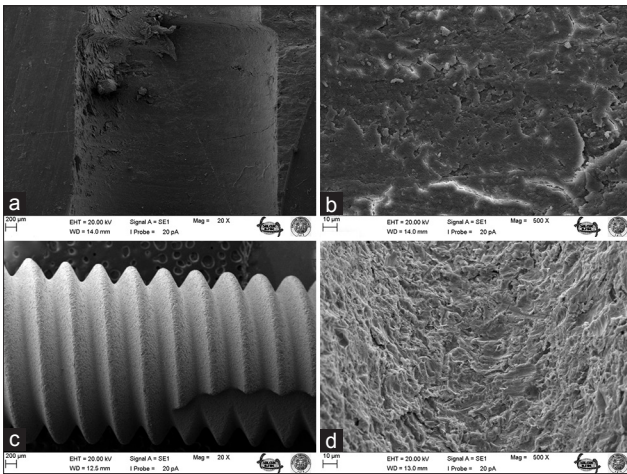
Figure 3: Bone surface before B implant screwing under $\times 20$ (a) and $\times 500$ (b) magnifications; surface of unscrewed B implant under $\times 20$ (c) and $\times 500$ (d) magnifications

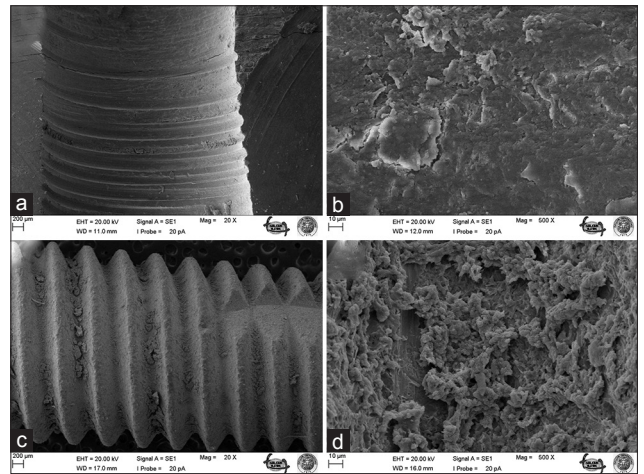
Figure 4: Bone surface after removal of B implant under $\times 20$ (a) and $\times 500$ (b) magnifications; surface of B implant after screwing and removal under $\times 20$ (c) and $\times 500$ (d) magnifications

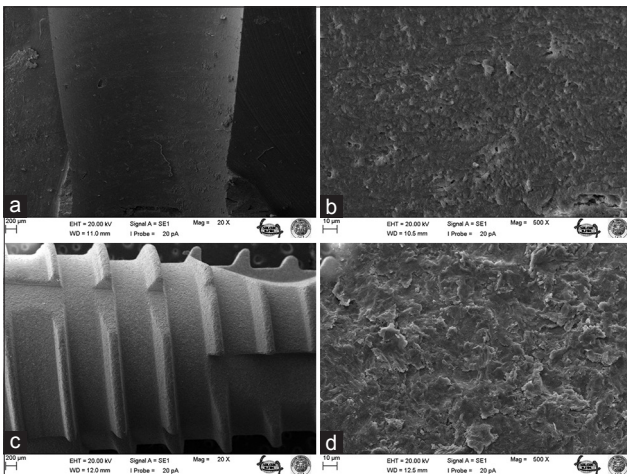
Figure 5: Bone surface before C implant screwing under $\times 20$ (a) and $\times 500$ (b) magnifications; surface of unscrewed C implant under $\times 20$ (c) and $\times 500$ (d) magnifications

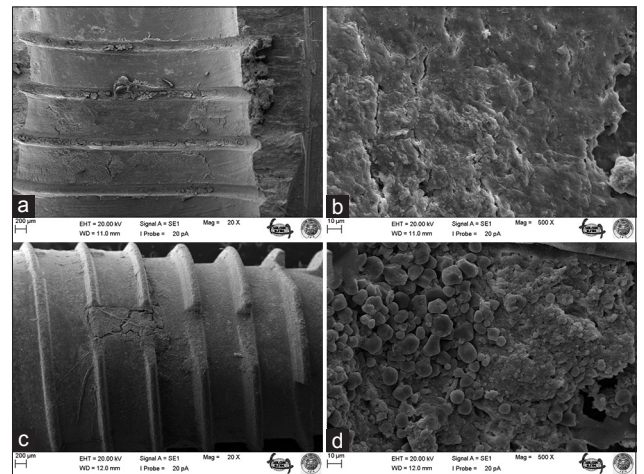
Figure 6: Bone surface after removal of C implant under $\times 20$ (a) and $\times 500$ (b) magnifications; surface of C implant after screwing and removal under $\times 20$ (c) and $\times 500$ (d) magnifications
