E-Videos

Guidewire malposition outside the bile duct during endoscopic ultrasound-guided hepaticogastrostomy

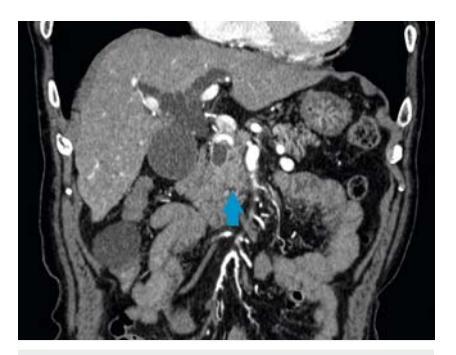
▶ Fig.1 Preprocedure coronal computed tomography showing a dilated bile duct due to pancreatic head cancer (arrowhead).

An 80-year-old man with biliary obstruction due to pancreatic cancer (▶ Fig. 1) was referred to our hospital for EUS-HGS because of prior ERCP failure. During the procedure, the bile duct of segment 3 (B3) was punctured using a 19-G needle (EZ Shot 3 Plus; Olympus Medical, Tokyo, Japan), and contrast medium was injected into the bile duct. A guidewire (Visi-Glide 2 Guidewires; Olympus Medical) was advanced toward the biliary tract without resistance (▶ Fig. 2 a). After dilation of the fistula, contrast was noted outside the bile duct, suggesting guidewire malposition (▶ Fig. 2 b).

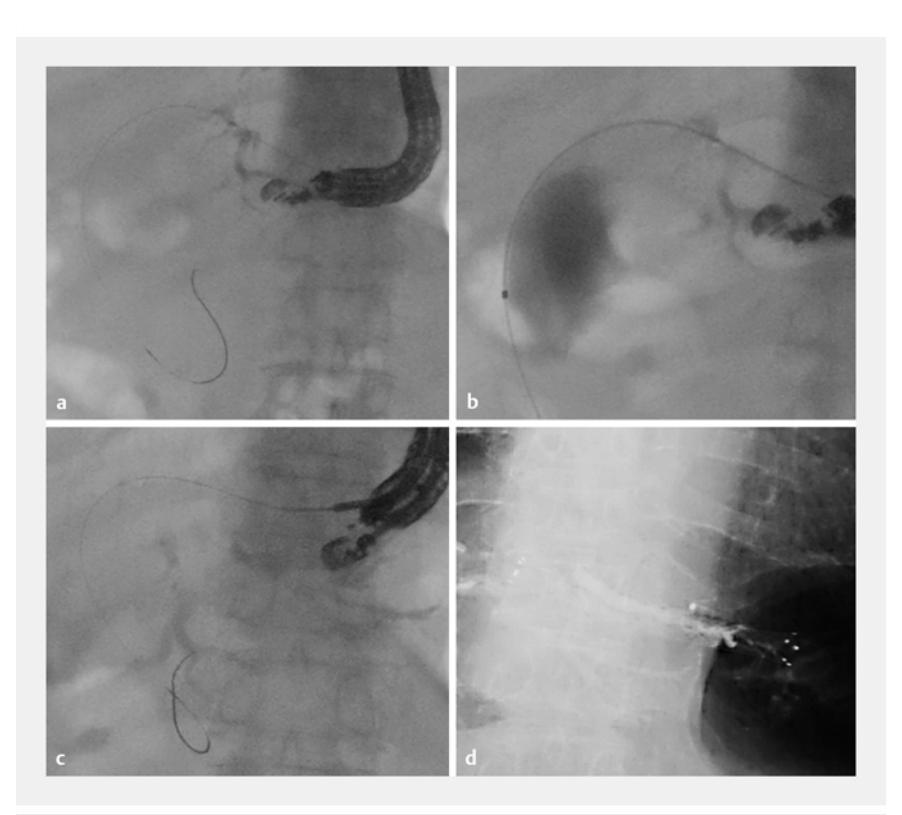
▶ Fig. 2 Fluoroscopic images from endoscopic ultrasound-guided hepaticogastrostomy (EUS-HGS) performed for biliary obstruction in an 80-year-old man with pancreatic head cancer. **a** In the first procedure, the bile duct of segment 3 (B3) was punctured and a guidewire was advanced toward the biliary tract. **b** Guidewire malposition was identified based on contrast extravasation outside the bile duct. **c** For salvage drainage, the bile duct of segment 2 (B2) was punctured and a guidewire was inserted into the biliary tract. **d** A self-expandable metal stent was placed during the EUS-HGS.

EUS-HGS on the bile duct of segment 2 (B2) was performed for salvage drainage. After the guidewire was inserted into the biliary tract (**> Fig.2c**) and fistula dilation was performed, a fully covered selfexpandable metal stent (X-Suit NIR Biliary Metallic Stents; Olympus Medical)

was inserted (**> Fig.2d**). Although the post-EUS-HGS computed tomography showed hematomas around the liver and spleen (**> Fig.3**), the patient was discharged from our hospital after conservative treatment.

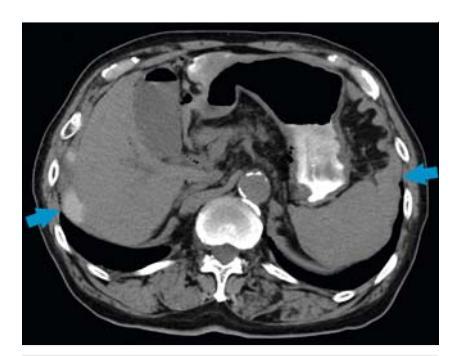
► Fig. 3 Postprocedure axial computed tomography showing hematomas around the liver and spleen (arrowheads).

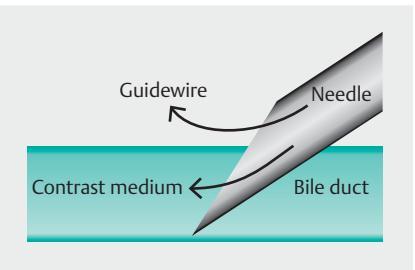
► Fig. 4 Relationship between the needle and bile duct in guidewire malposition. The needle tip is not completely inside the bile duct. As a result, although the contrast medium was injected into the bile duct, the guidewire migrated outside the bile duct.

The probable cause of incorrect advancement of the guidewire was incomplete placement of the needle tip within the bile duct. As a result, although the contrast medium was injected into the bile duct, the guidewire migrated outside the bile duct (► **Fig. 4**). Fluoroscopy showed that the two guidewires had a similar shape; however, their loop widths were different (► **Fig. 5 a, b**). Recent advances have enabled EUS-HGS to be performed without fistula dilation, using a self-expandable metal stent with a small-diameter delivery system [3, 4]. It is necessary to evaluate the shape of the guidewire before stent placement during EUS-HGS without fistula dilation.

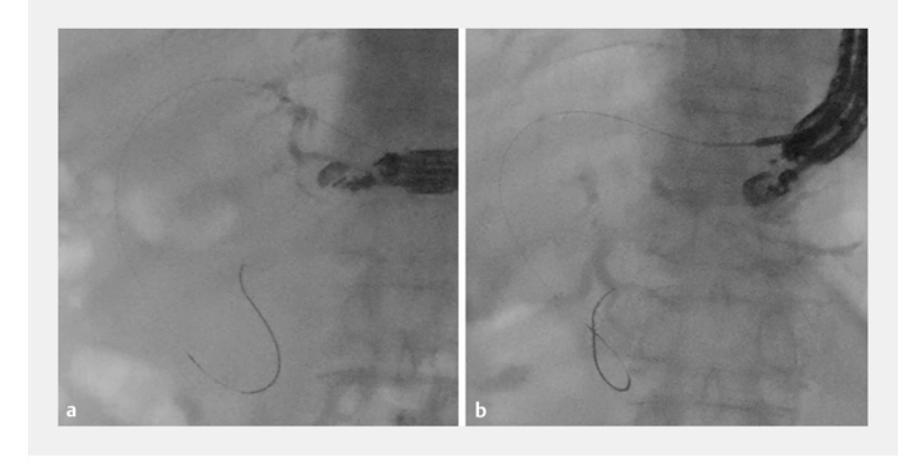
▶ Fig. 5 Fluoroscopic images showing the shape of the guidewire. Although the two guidewires had a similar shape, their loop widths were different. a Guidewire malposition outside the bile duct. b Correct insertion of the guidewire into the common bile duct.
