Laparoscopic Cholecystectomy-Induced **Complex Common Bile Duct Injury: Will Rescue ERCP Help?**

| Digest Endosc 2024;15:147-149.

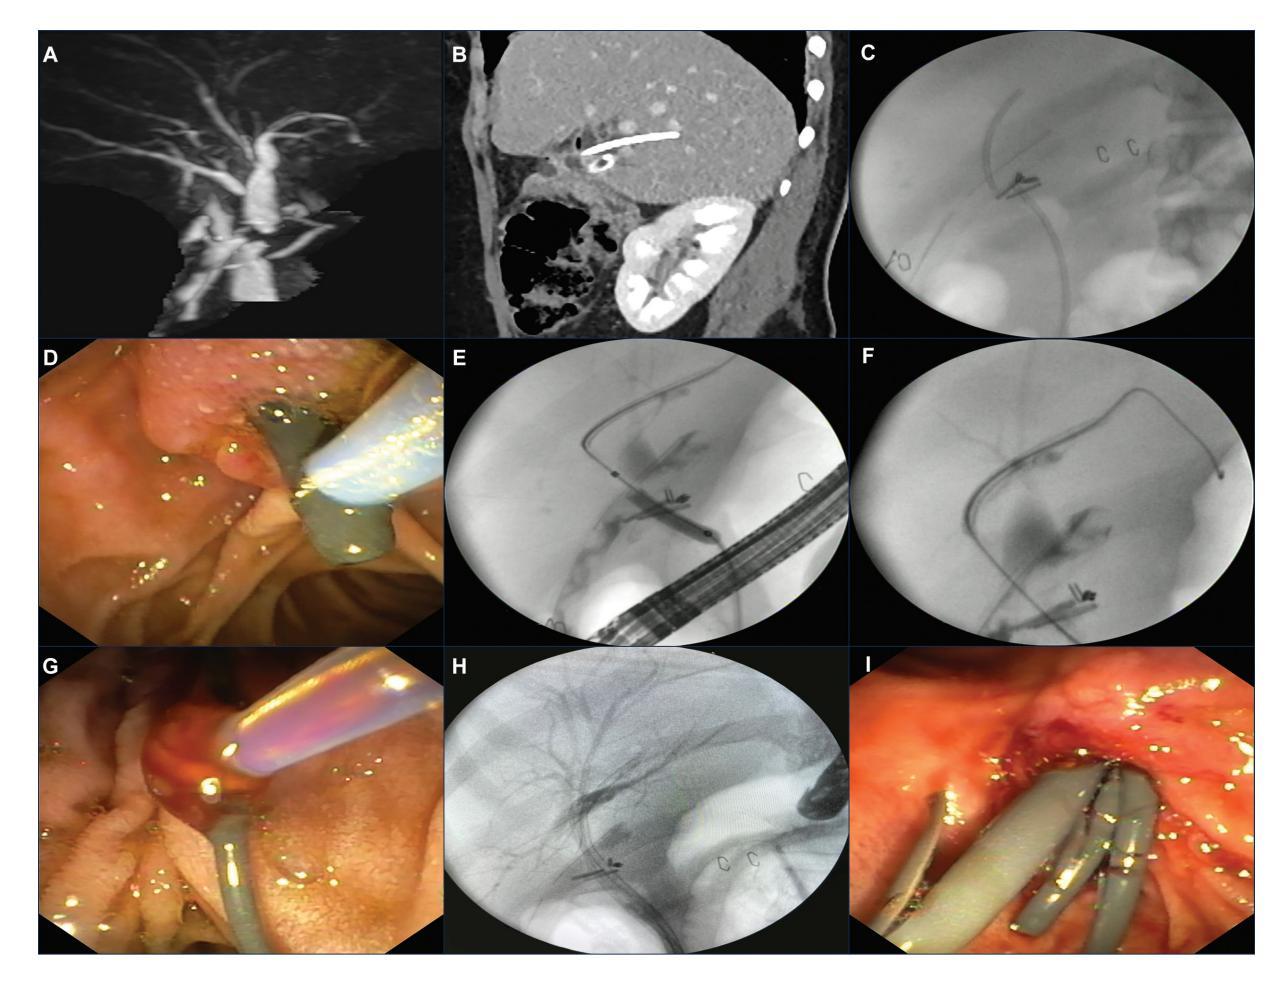
Fig. 1 (A) Magnetic resonance cholangiopancreatography (MRCP) showing complete transection of common bile duct (CBD) near confluence. (B) Computed tomography (CT) showing sagittal view of fragmented CBD stent. (C) Fluoroscopy showing proximal and distal fragmented stents surrounded by surgical clips. (D) Endoscopy showing the distal end of the fragment being removed. (E) Hurricane biliary balloon dilatation at the clipped site of CBD. (F) Fluoroscopy showing contrast being injected and near-complete cutoff of contrast below the confluence. (G) Endoscopy showing proximal stent being removed by endoscopic mucosal resection (EMR) snare. (H) Fluoroscopy showing plastic stents being placed in the right and left hepatic ducts. (I) Endoscopy showing placement of three plastic stents.

After selective wire-guided cannulation of the CBD at ERCP, a distal fragment of the CBD stent was removed with a snare (Fig. 1A-I). A hurricane biliary balloon dilatation

catheter (Boston Scientific, United States) was used to enter and dislodge the clipped CBD site. A guidewire (Dreamwire, Boston Scientific) was then passed through the clipped segment of the CBD into the right posterior duct. Using an endoscopic mucosal resection snare (SD-221L-25, Olympus, United States), the proximal end of the fragment was removed. The contrast was injected, and there was a nearcomplete cutoff of contrast at the confluence. Selectively, the guidewires were placed in the right anterior, right posterior, and left hepatic ducts. A 10F plastic stent (Endotech, India) was placed in the left hepatic duct and $2 \times 7F$ plastic stents (Endotech) were placed in the right anterior and right posterior ducts, respectively. Following this patient was followed up for drain output, which gradually reduced. At follow-up (3 weeks), her total bilirubin had normalized from 56.4 to 18.8 mmol/L. At 8 weeks, she was asymptomatic and her bile leak had stopped. Her stents were upgraded from 7F to three 10F plastic stents as per the Costamagna protocol. The next plan for her is to undergo routine ERCP with a check cholangiogram, post which she will be given a stent-free trial.
