The Bubble Eye Sign: Understanding the Radiological Imaging of Gas inside the Orbit

Indian J Radiol Imaging 2021;31:451–453.

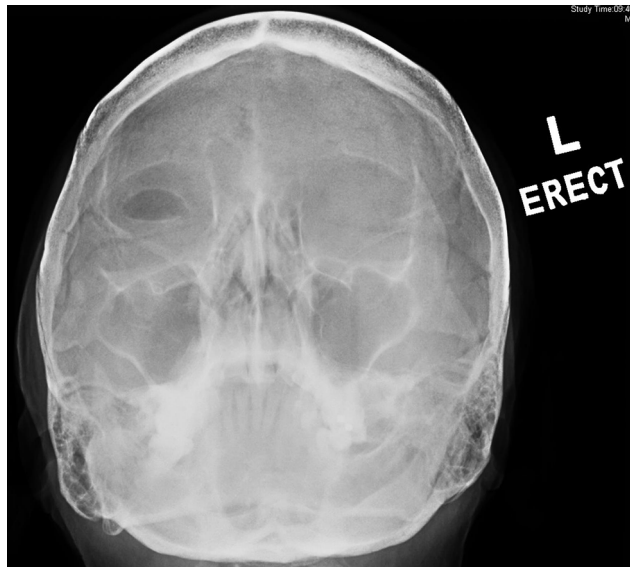
Fig. 1 The bubble eye sign. Orbital X-ray (Waters' view) showing radiolucency over the right orbit. The gas was taking the configuration of a bubble, compatible with gas-filled intravitreal cavity confounded by the eyeball.

A 58-year-old lady underwent pars plana vitrectomy with intravitreal gas (14% C₃F₈) tamponade for retinal detachment repair. She complied with prone posture and surgical wounds were stable postoperatively. Unfortunately, she fell down the stairs at home the day after discharge from hospital, and readmitted for head injury. Investigation by skull X-ray showed radiolucency over the right orbit in bubble configuration (▶ **Fig. 1**). Attending emergency physician further worked up with computed tomography scan to rule out orbital fractures which revealed negative density within the vitreous cavity (−990 to −400 Hounsfield's unit) with the shape of the eyeball maintained (▶ **Fig. 2**).

Volume of intravitreal gas is larger than intracameral gas, and the approximated sphere shaped vitreous cavity allows the intravitreal gas to keep its bubble configuration throughout the whole resorption stages. As gas is radiolucent on radiography, intravitreal gas appears as a radiolucency bubble on X-ray and computed tomography, bounded by the scleral shell, outlining the shape of the eyeball. This "Bubble Eye sign" differentiates intravitreal gas from small orbital emphysema in orbital fracture, when gas is located outside the globe but confined by the orbit, giving a crescent or concave shape usually flowing upwards over the superior orbit (► Figs 3–5).

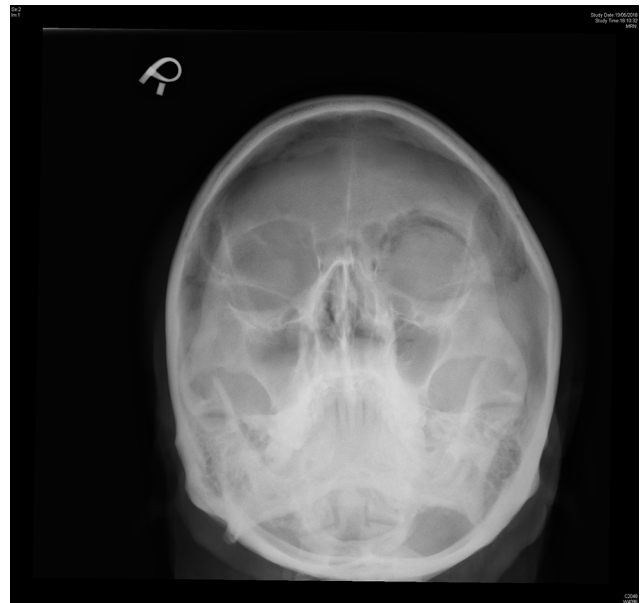
Fig. 3 Orbital X-ray (Waters' view) of another orbital fracture case for comparison. Left orbital emphysema classically seen after orbital fracture was evidenced by the rim of radiolucent gas over the superior orbit. It also outlined the eyeball position, but by its extraocular location.

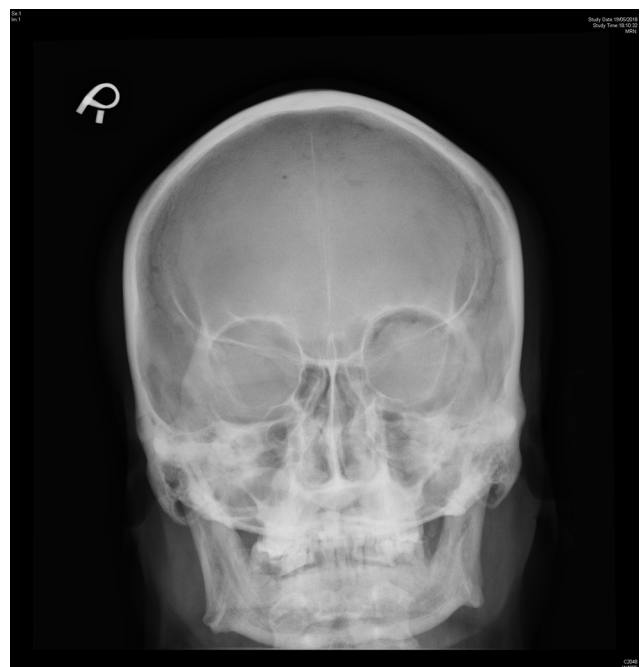
Fig. 4 Orbital X-ray (Caldwell's view) of the same patient in Fig. 3. Discontinuity of the left medial orbital wall suggested the site of orbital fracture.
