## Treatment of tumor associated hemobilia with a partially covered metallic stent

DOI 10.1055/s-2007-966555  
*Endoscopy* 2007; 39: E225

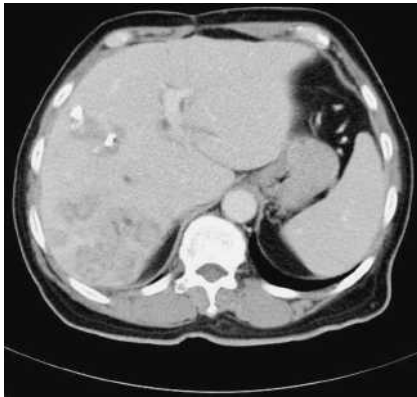
**Figure 1** CT scan demonstrates multiple metastatic lesions in the right lobe of the liver with lipiodol stain in the old lesion.

A 66-year-old Thai man presented with fever, jaundice and melena. He had an underlying condition of rectal adenocarcinoma treated by low anterior resection and had recently developed liver metastasis. A CT scan of the abdomen showed new advanced lesions occupying the right posterior segment of the liver (● **Figure 1**). The endoscopic finding during endoscopic retrograde cholangiopancreatography (ERCP) revealed active oozing of blood from the biliary orifice. The cholangiogram demonstrated an amorphous filling defect occupying the extrahepatic biliary tree with a concave mass sitting at the hepatic hilum (● **Figure 2** and **3**). Balloon sweeping was performed many times but it seemed that the blood oozing from the papilla never stopped.

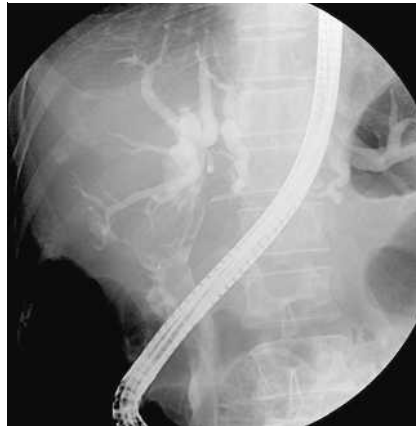
**Figure 2** Cholangiogram demonstrates clot and tumor in the bile duct.

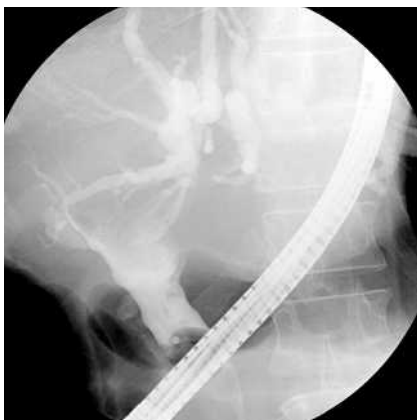
**Figure 3** After clot removal, a concave mass was seen at the hepatic hilum.

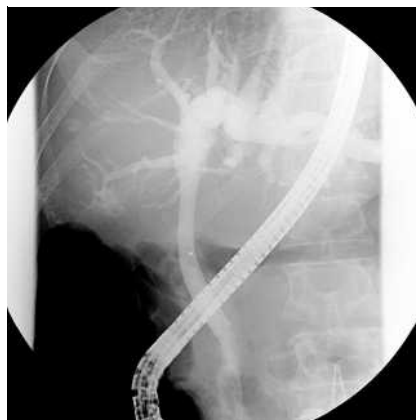
**Figure 4** After metallic stent insertion, good drainage of contrast was seen and the filling defect was no longer detected.

Ultimately, we decided to put in a partially self-expandable metallic stent (SEMS). The stent was inserted with the proximal non-covered end placed in the left intrahepatic duct system. The technique for deployment was similar to the standard technique, but fluoroscopic monitoring was continued at all times to confirm the precise location of the SEMS placement. The oozing stopped immediately, with pure dark bile gushing out from the biliary orifice. The final cholangiogram confirmed a clear extrahepatic duct (● **Figure 4**). Within a week, the obstructive jaundice resolved and the patient's hemoglobin level was stable. No further bleeding occurred before the patient's death 10 months later.
