Abnormal hand position leading to possible brachial plexus injury during spinal interventional neuroradiology: Are we aware of it?

Amarjyoti Hazarika, Shailendra Kumar, Meena Singh¹

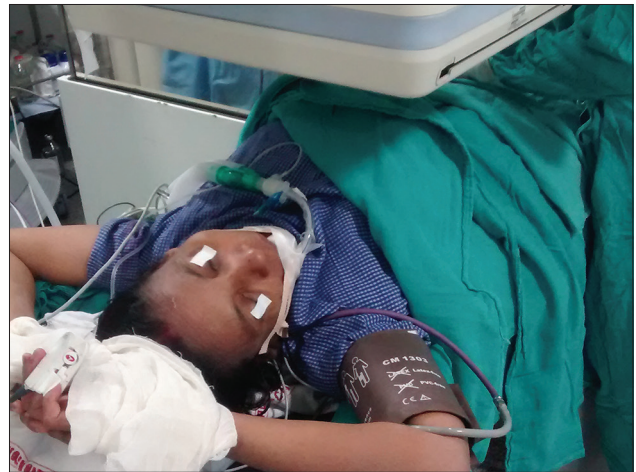
Figure 1: Shows arms are abducted more than 90 degree at shoulder joints

Proximally, the brachial plexus is anchored to vertebrae and prevertebral fascia, while distally it is anchored to the axillary sheath, stretching brachial plexus causing injury to the nerve.^[2] Several factors predispose to plexus injuries, including 90° or greater arm abduction, extension of the upper extremity, external rotation of the upper extremity.^[3] Pillai *et al.* have mentioned the grave risk of plexus injury during IN if the arms are abducted beyond 90°.^[4] Preventive measures are to maintain flexion of all joints of the upper limbs below 90°.^[5] There are no specific guidelines in the literature to prevent plexus injury during spinal IN nor any modification have been made in the design and function of the imaging equipment to overcome interference from normally placed hands. It is imperative for everyone to have knowledge about this danger while performing spinal IN procedure and appropriate measures should be taken for carrying out intervention without injuring the neural structures.
